REMEDIAL INVESTIGATION SUMMARY
FORMER GIBBLE'S QUARRY
MANHEIM BOROUGH, LANCASTER COUNTY, PENNSYLVANIA
PROJECT SVEI 1062G1

FEBRUARY 2008

REMEDIAL INVESTIGATION SUMMARY (RIS) REPORT

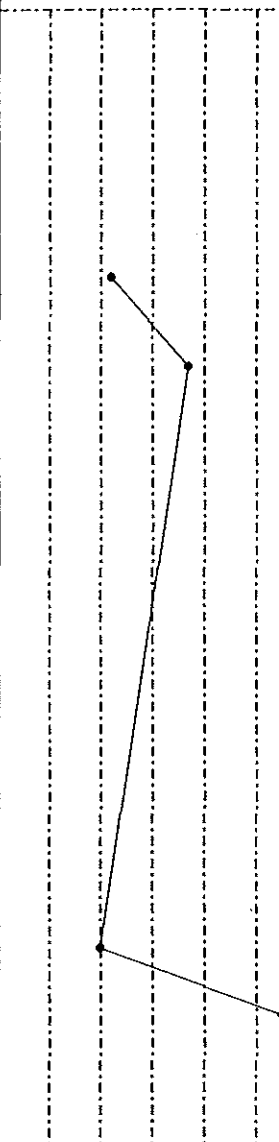
<p>Groundwater at 16.5' after 5 minutes.</p> <p>Hole collapsed after 24 hours.</p> <p>* Soil sample is moist.</p> <p>** Soil sample is wet.</p> <p>Starting at 14' below grade the foundry sand is mixed with 2A modified stone and ballst, probably related to the foundry sand dumping.</p> <p>Auger refusal at 24.5' depth after very hard augering through rock.</p>

1.0		Vegetation and roots.	424.1						
2.0		Fill material consisting of limestone derived soils, some shale, occasional construction debris.							
3.0

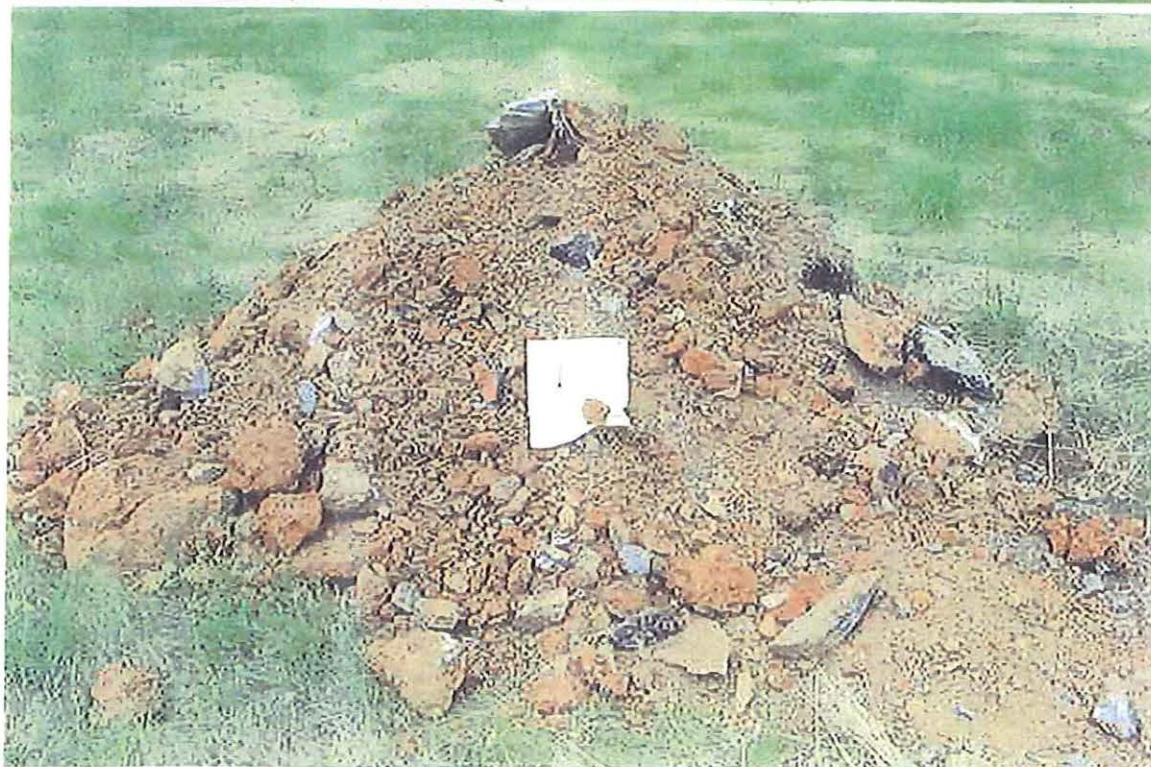
PROJECT 1062G1
GIBBLE'S QUARRY
PICTURE 1: Site view from Hazel Street (south)
PICTURE 2: Test pit #4, limestone soils
MANHEIM, LANCASTER COUNTY, PA

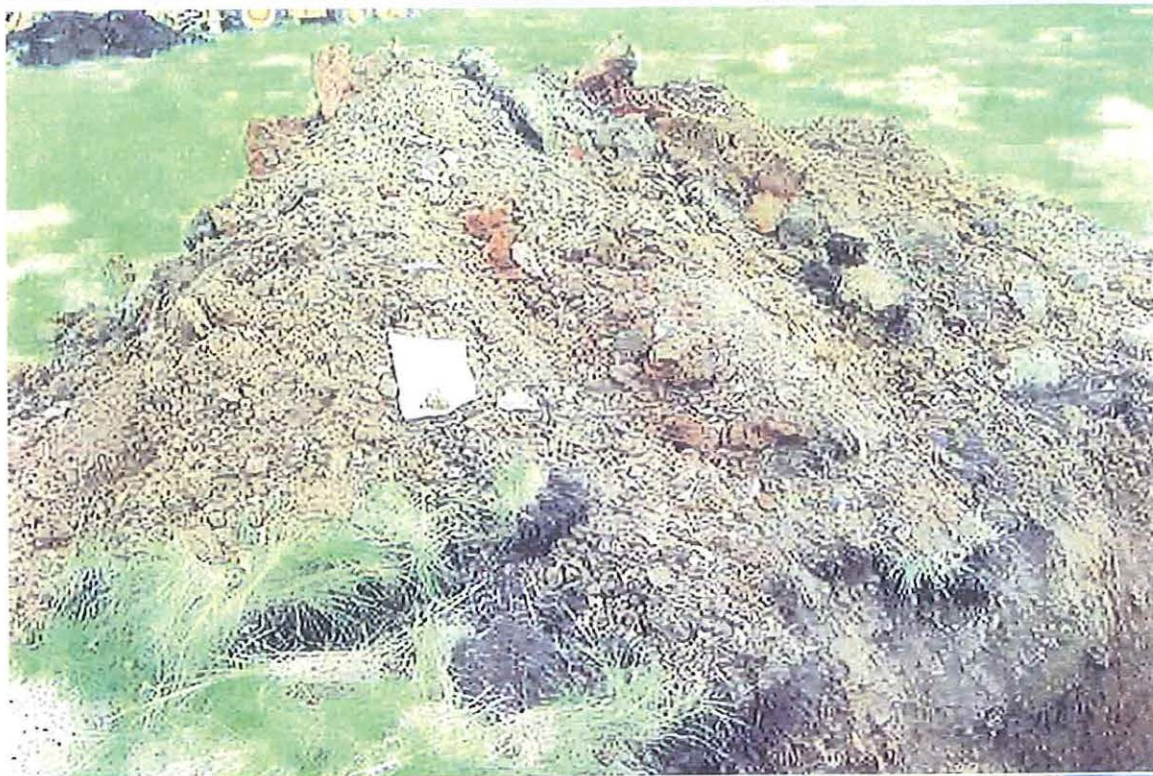
PROJECT 1062G1
GIBBLE'S QUARRY
PICTURE 3: Test Pit #3
PICTURE 4: Test pit #5, miscellaneous debris.
MANHEIM, LANCASTER COUNTY, PA

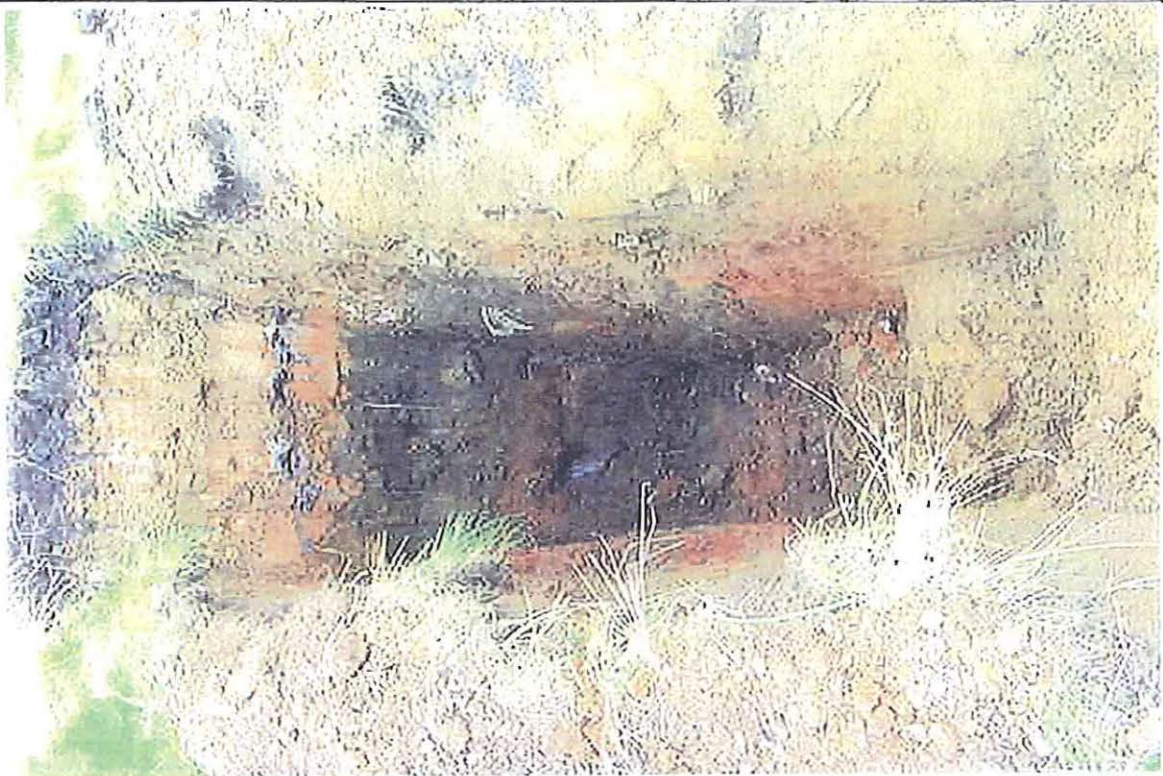
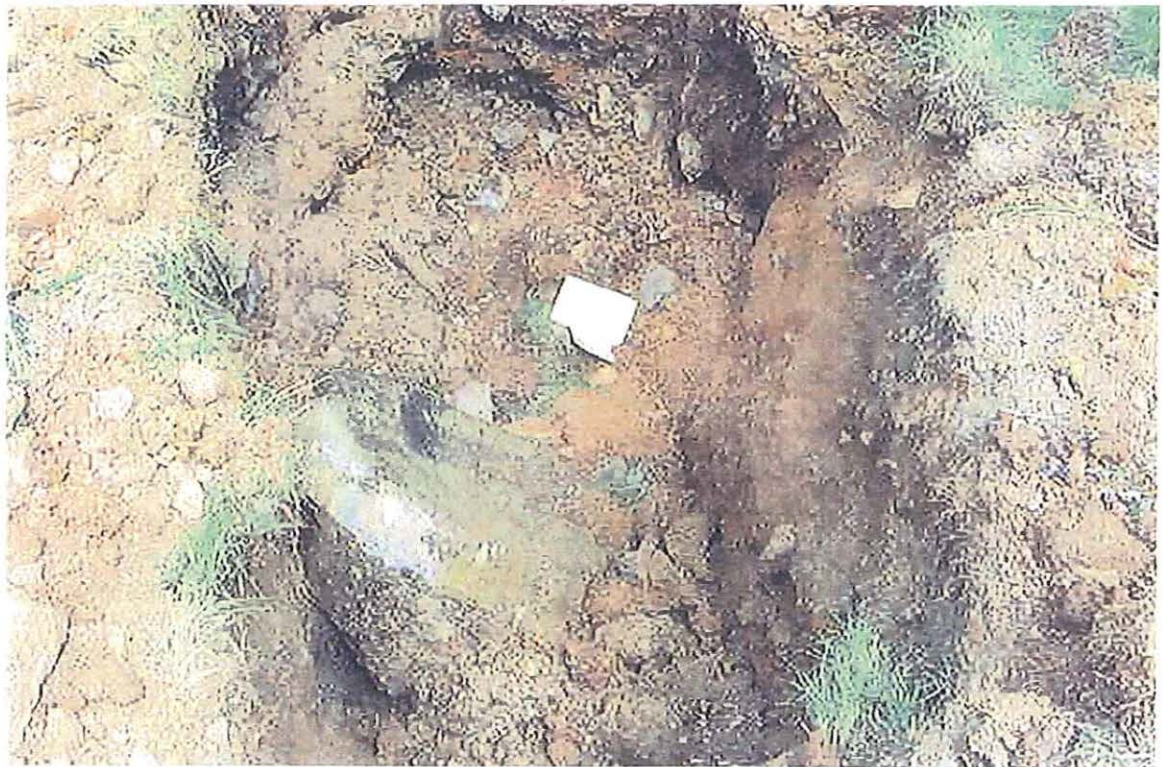
PROJECT 1062G1
GIBBLE'S QUARRY
PICTURE 5: Test Pit #13
PICTURE 6: Test pit #10, miscellaneous debris.
MANHEIM, LANCASTER COUNTY, PA

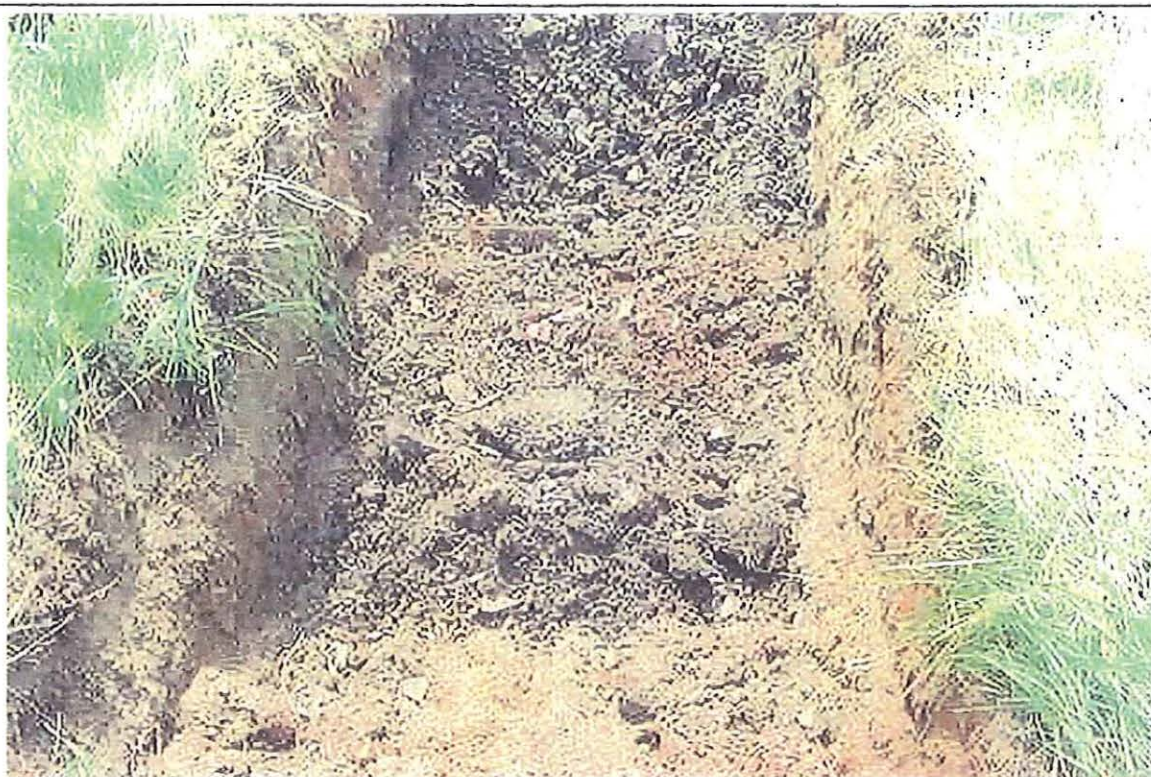
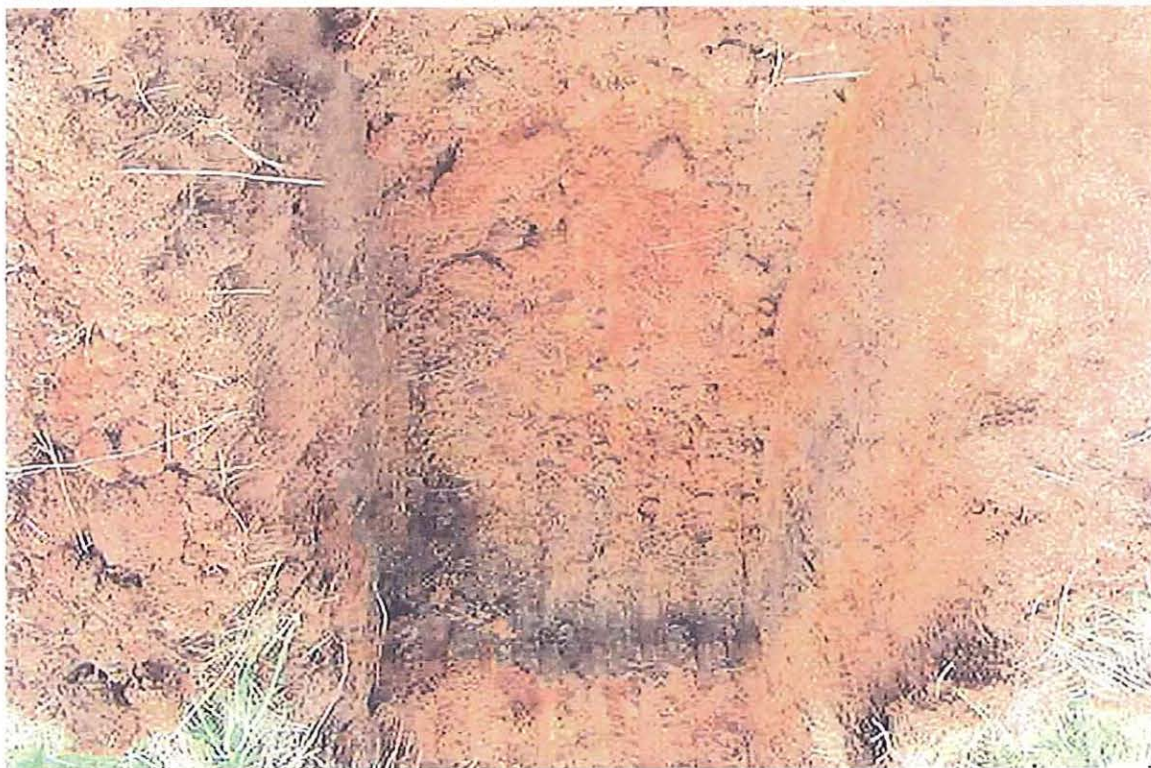
PROJECT 1062G1
GIBBLE'S QUARRY
PICTURE 7: Test pit #9, limestone soils.
PICTURE 8: Test pit #10, transition area.
MANHEIM, LANCASTER COUNTY, PA

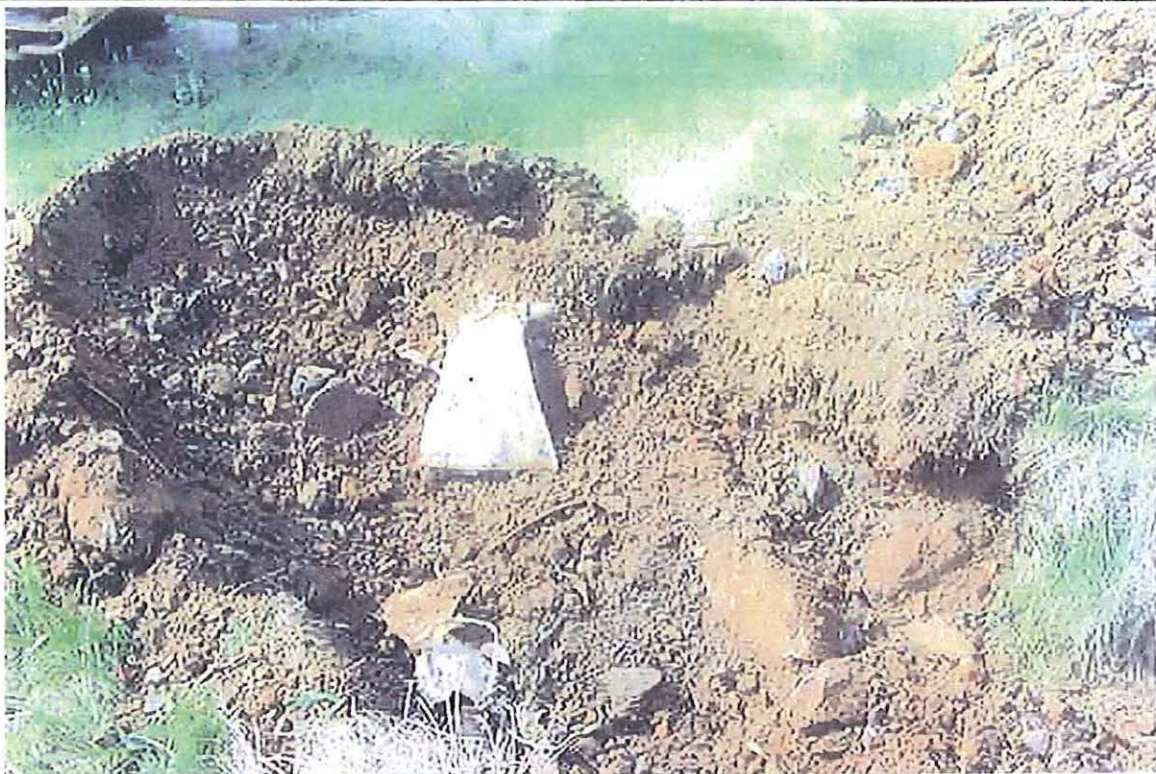
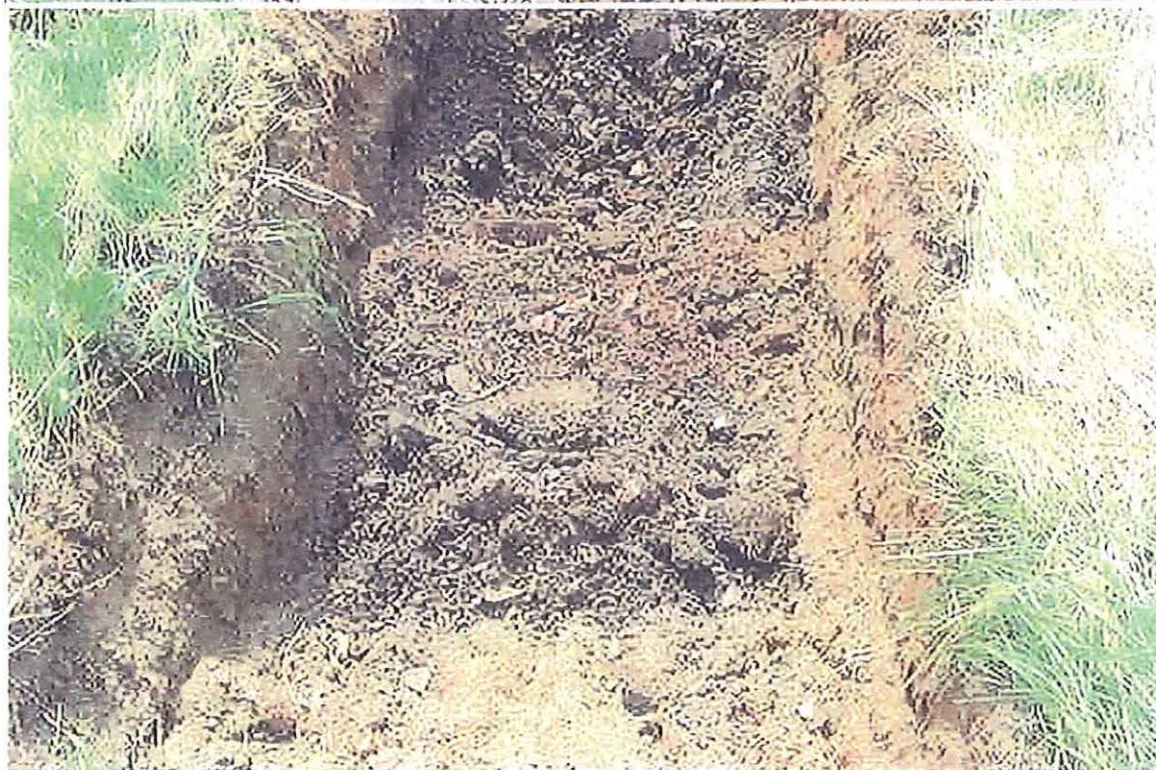
PROJECT 1062G1
GIBBLE'S QUARRY
PICTURE 9: Test Pit #9, limestone soils.
PICTURE 10: Test pit #18, shale soils.
MANHEIM, LANCASTER COUNTY, PA

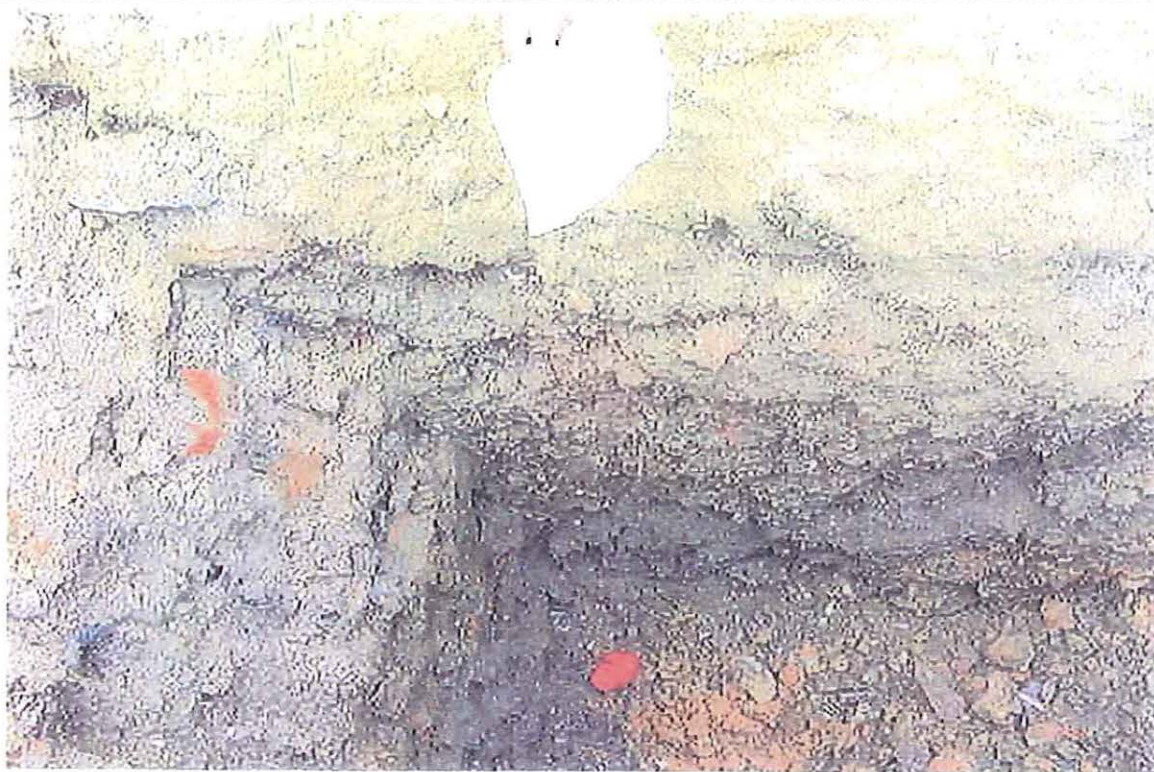
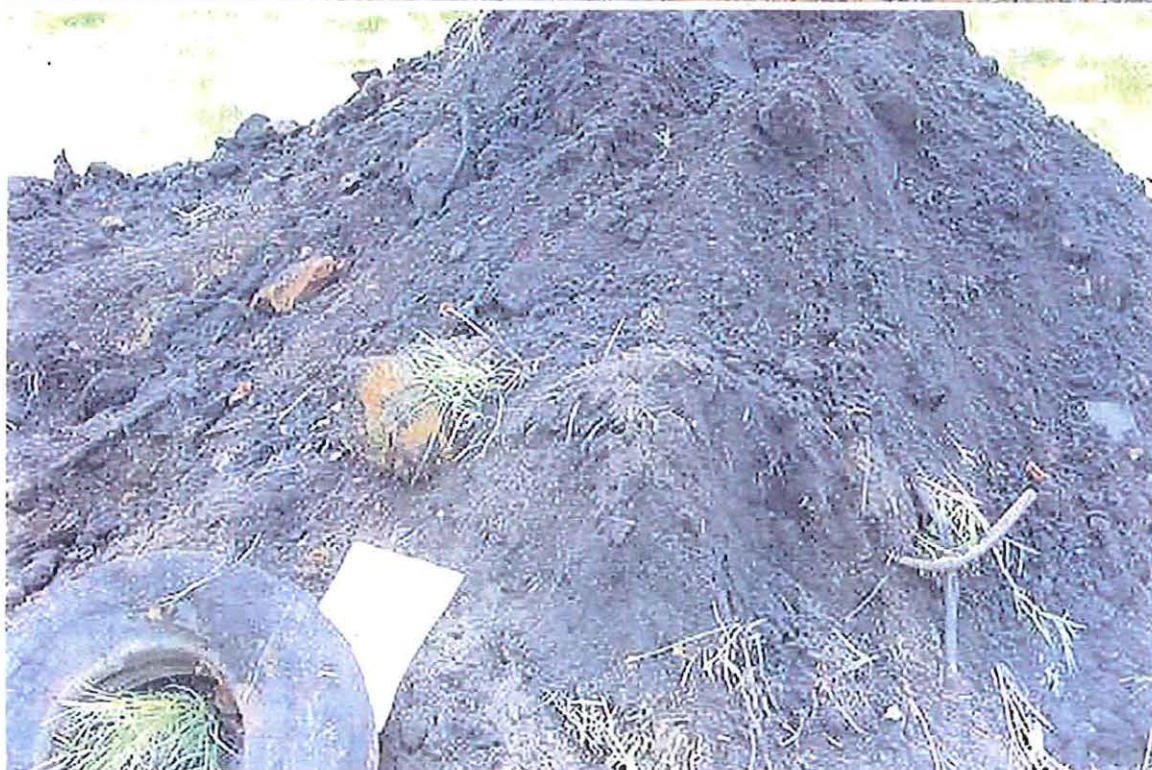
PICTURE 12: Test pit #17, miscellaneous soils.

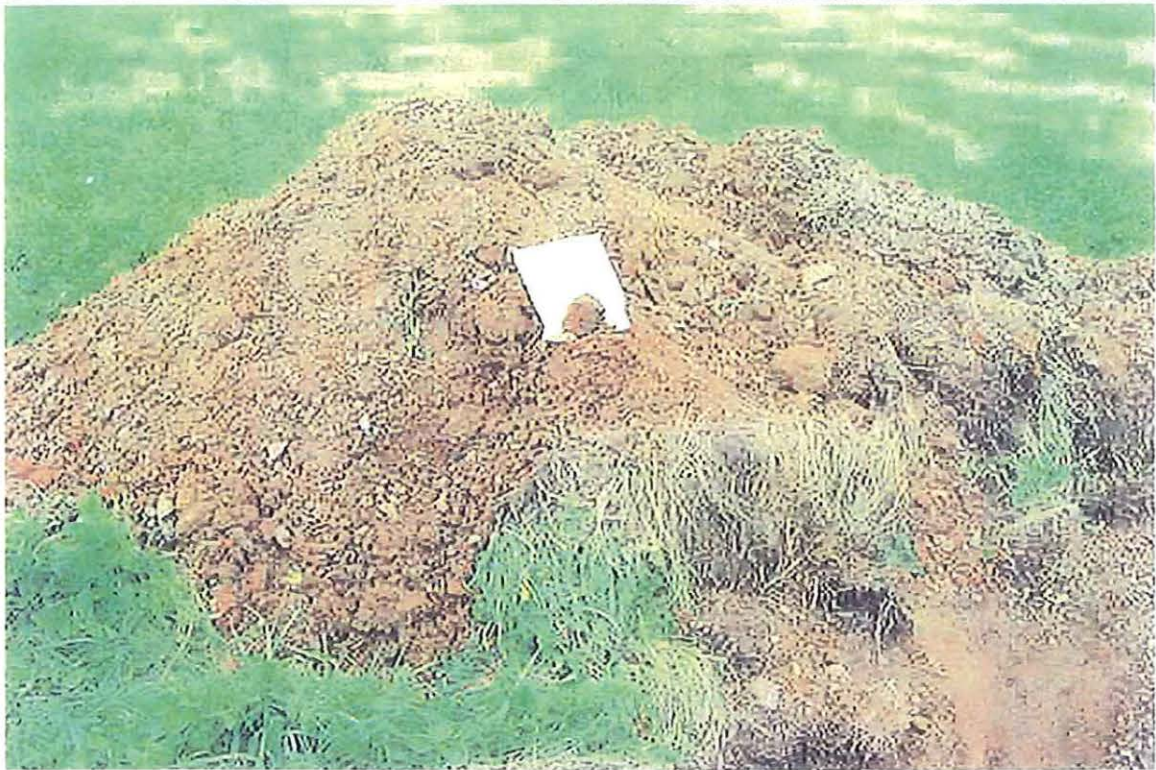
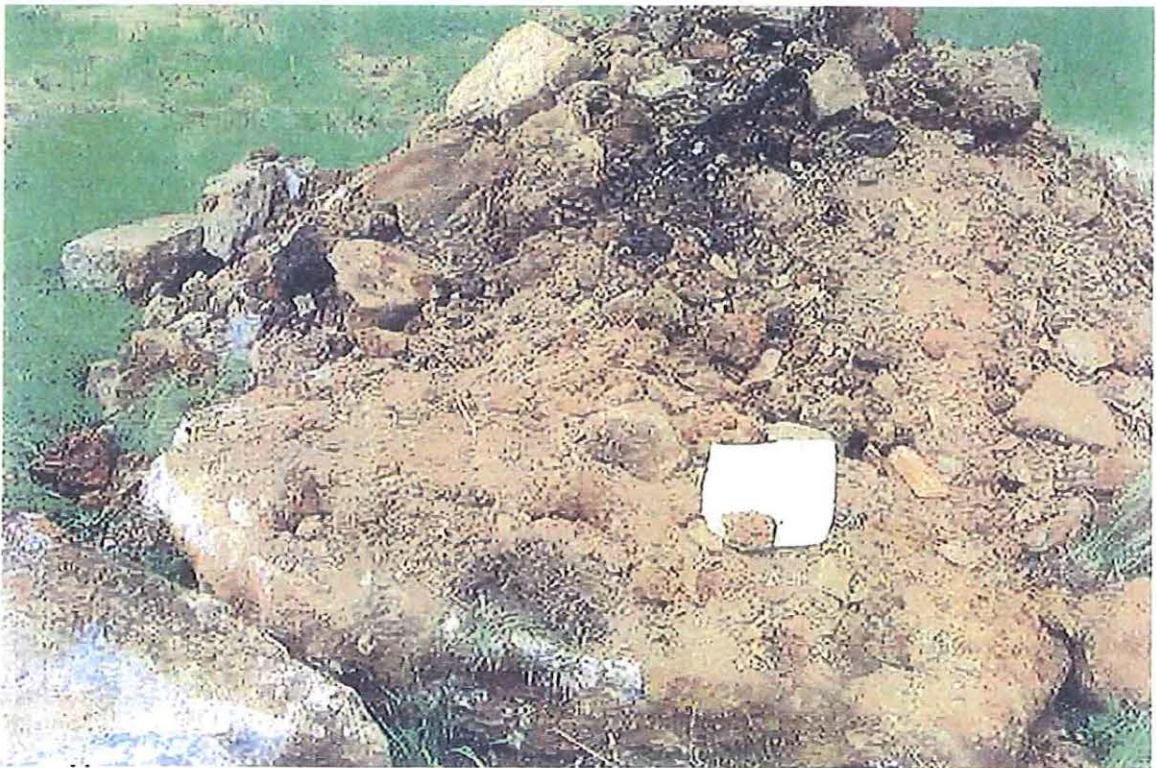
PROJECT 1062G1
GIBBLE'S QUARRY
PICTURE 13: Test Pit #10, transition area.
PICTURE 14: Test pit #8, miscellaneous soils.
MANHEIM, LANCASTER COUNTY, PA

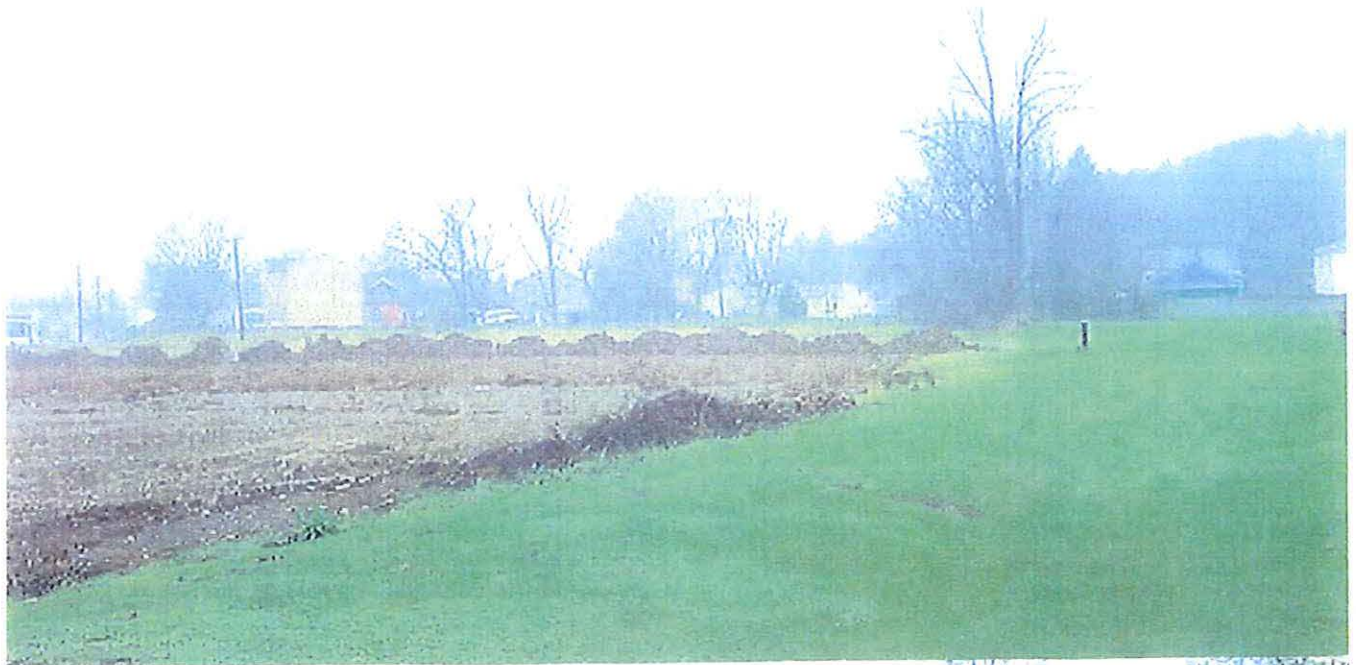
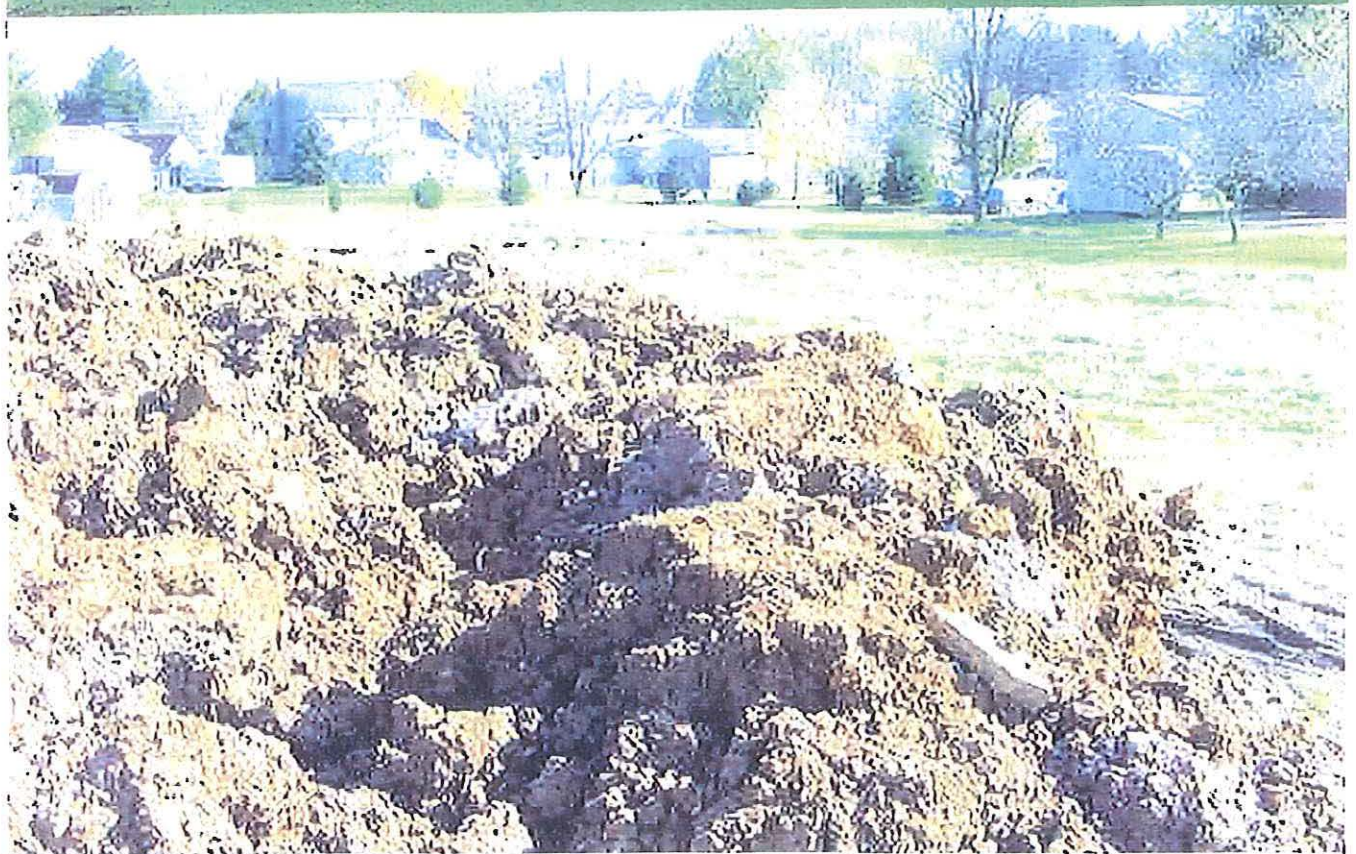
PICTURE 15: Fill material placement (northern side).
PICTURE 16: Fill material placement (southwest side).
MANHEIM, LANCASTER COUNTY, PA

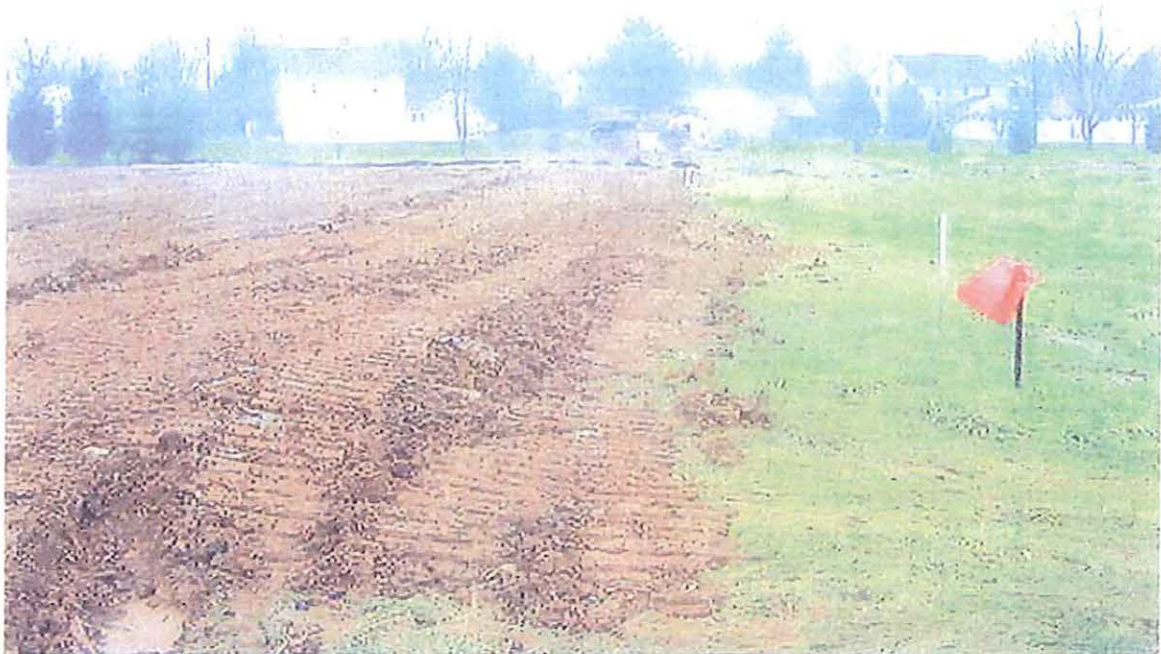
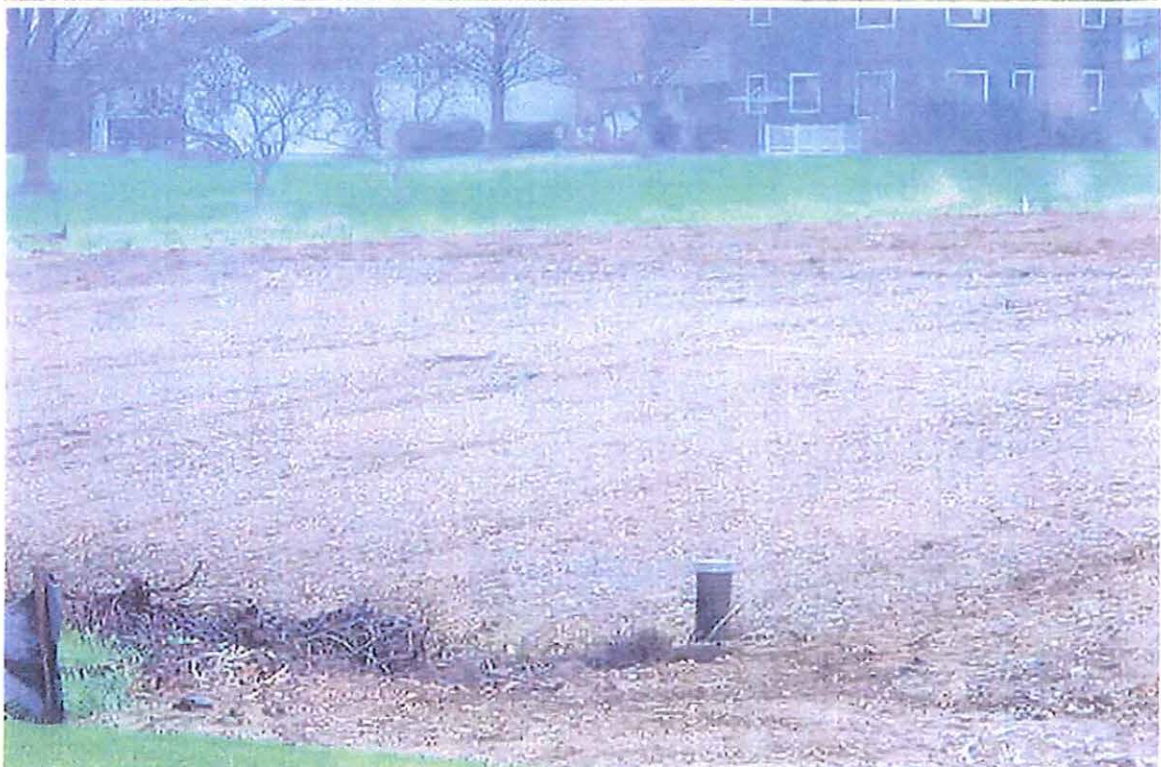
PICTURE 18: Fill material placement (eastern side).
